U.S. DEPARTMENT OF THE INTERIOR
GEOLOGICAL SURVEY

**PROGRESS OF STUDIES ON THE IMPACT OF
HURRICANE HUGO ON THE COASTAL
RESOURCES OF PUERTO RICO**

U. S. Geological Survey Open-File Report 92-717

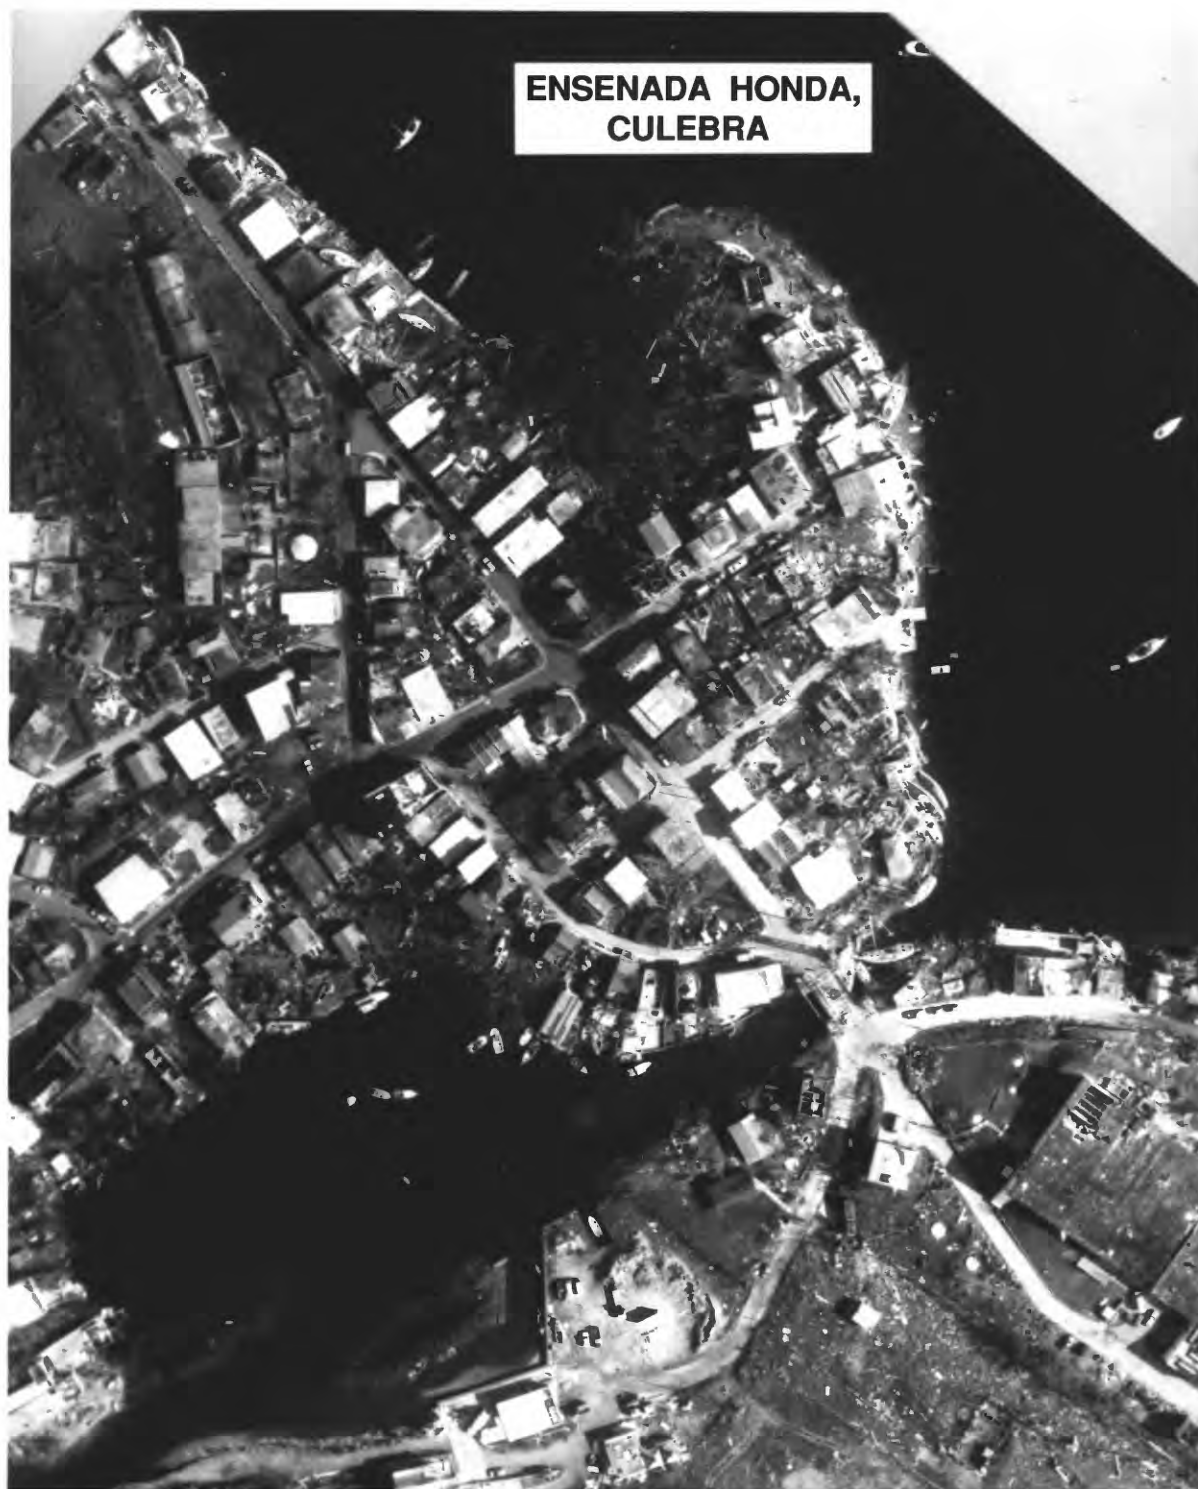
ENSENADA HONDA,
CULEBRA

Fig. 3. Aerial photograph of Ensenada Honda, Culebra, Puerto Rico taken on October 1989. Strong winds combined with the storm surge jammed four sailboats under the bridge. Approximately 100 vessels out of 300 that took shelter in the "hurricane proof" harbor sank. The distance across the bottom of this photograph is approximately 340 m. North is toward the top of the photograph.

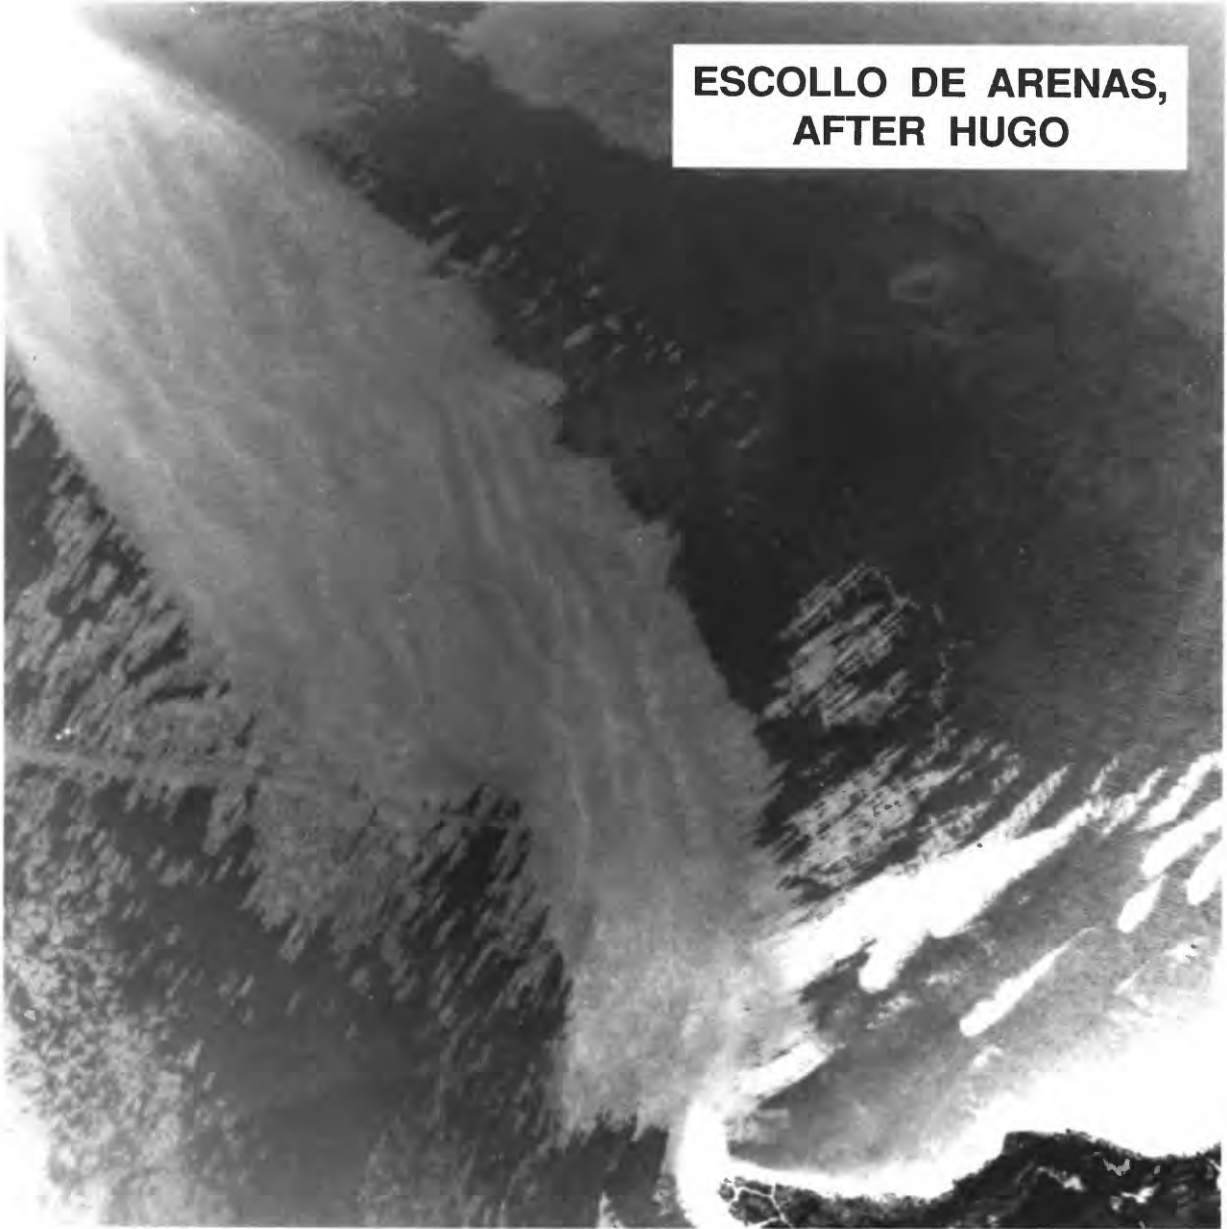
**ESCOLLO DE ARENAS,
AFTER HUGO**

Fig. 2. Post-Hugo aerial photograph of Escollo de Arenas. North is towards the top of the photograph. Note that sand ridges on the Escollo de Arenas are suppressed in comparison to the pre-Hugo photograph. See Figure 6 for scale.

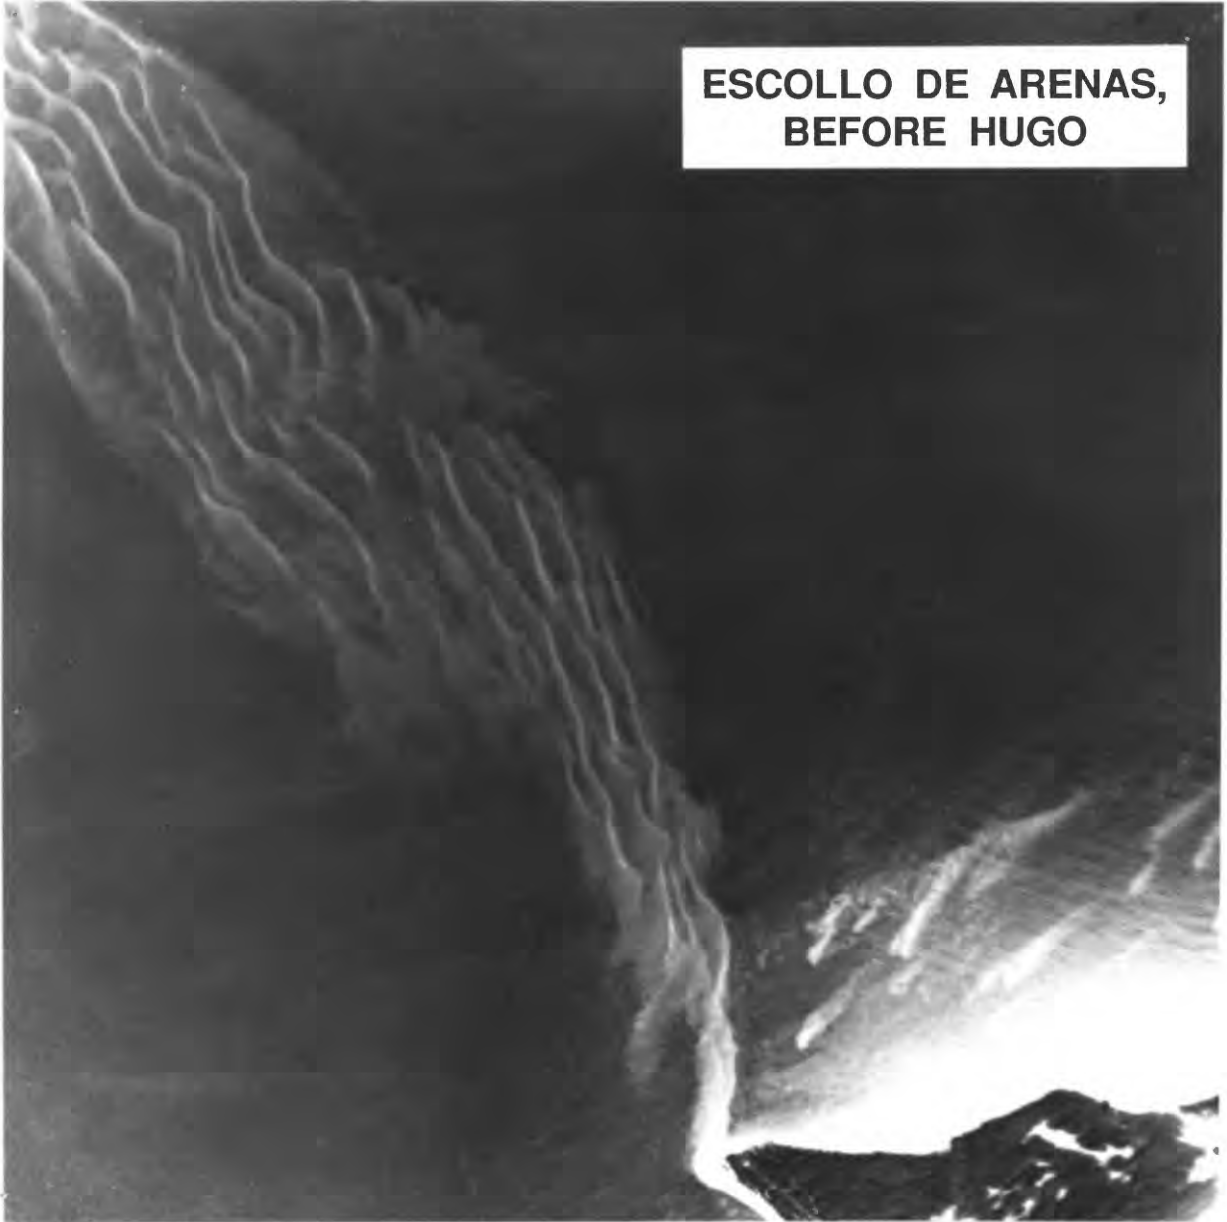
**ESCOLLO DE ARENAS,
BEFORE HUGO**

Fig. 3. Pre-Hugo aerial photograph of all but the northern limit of the Escollo de Arenas showing prominent sinuous-crested sand waves extending parallel to the axis of the shoal (from Rodriguez and Trias, 1989). See Figure 6 for scale.

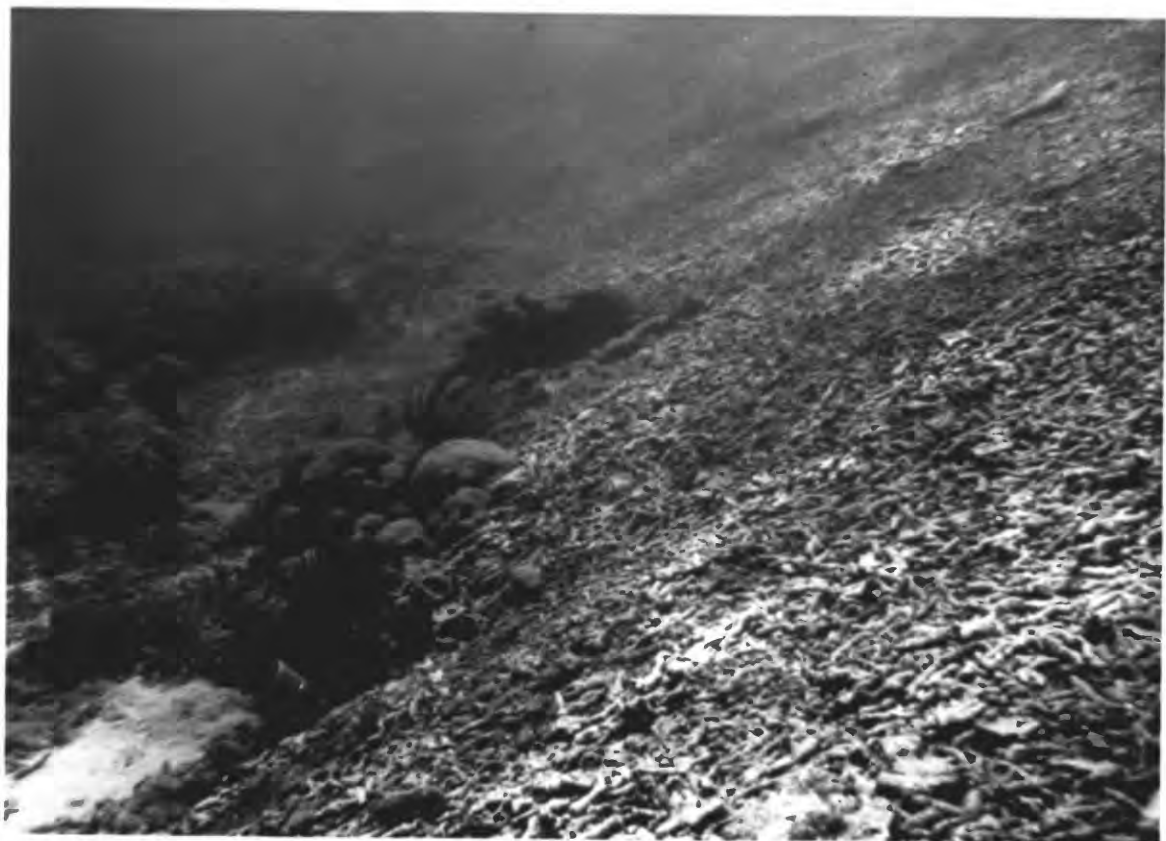
Fig. 6. Composition of the sand fraction for beach and low backscatter sands. These sediments are extremely similar and are predominantly composed of skeletal carbonate material.

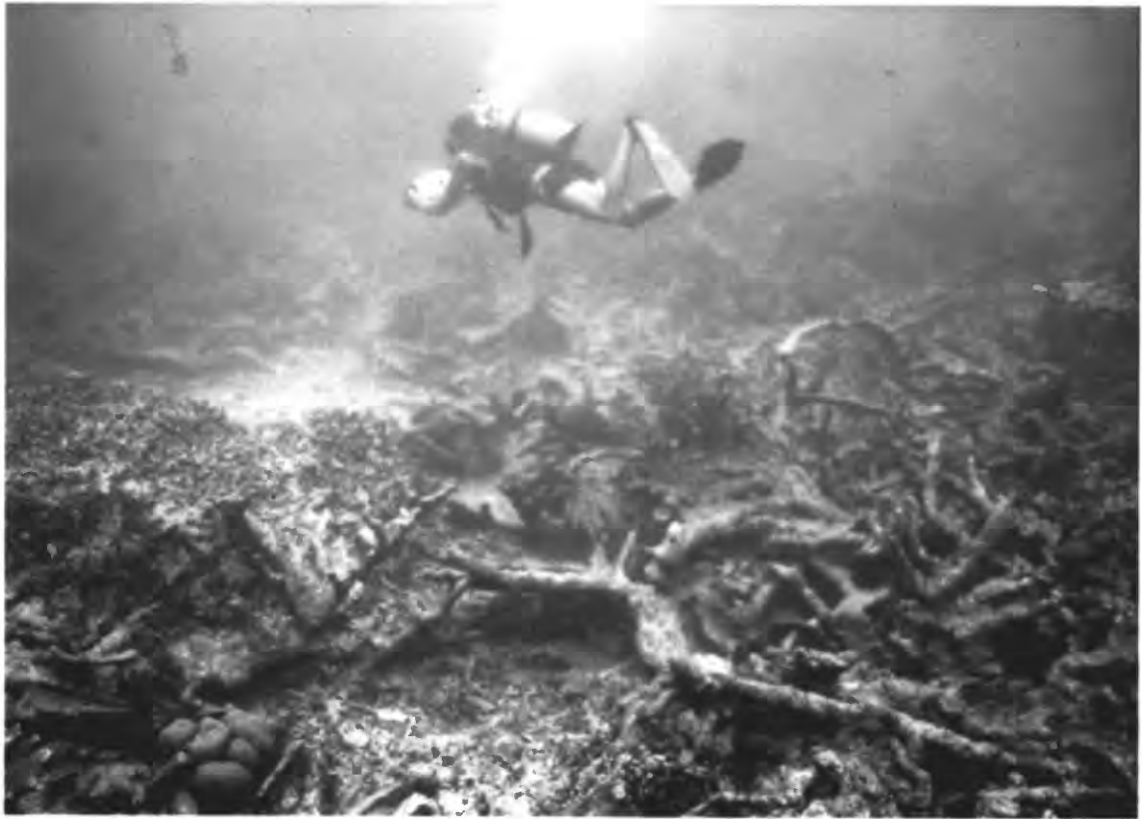
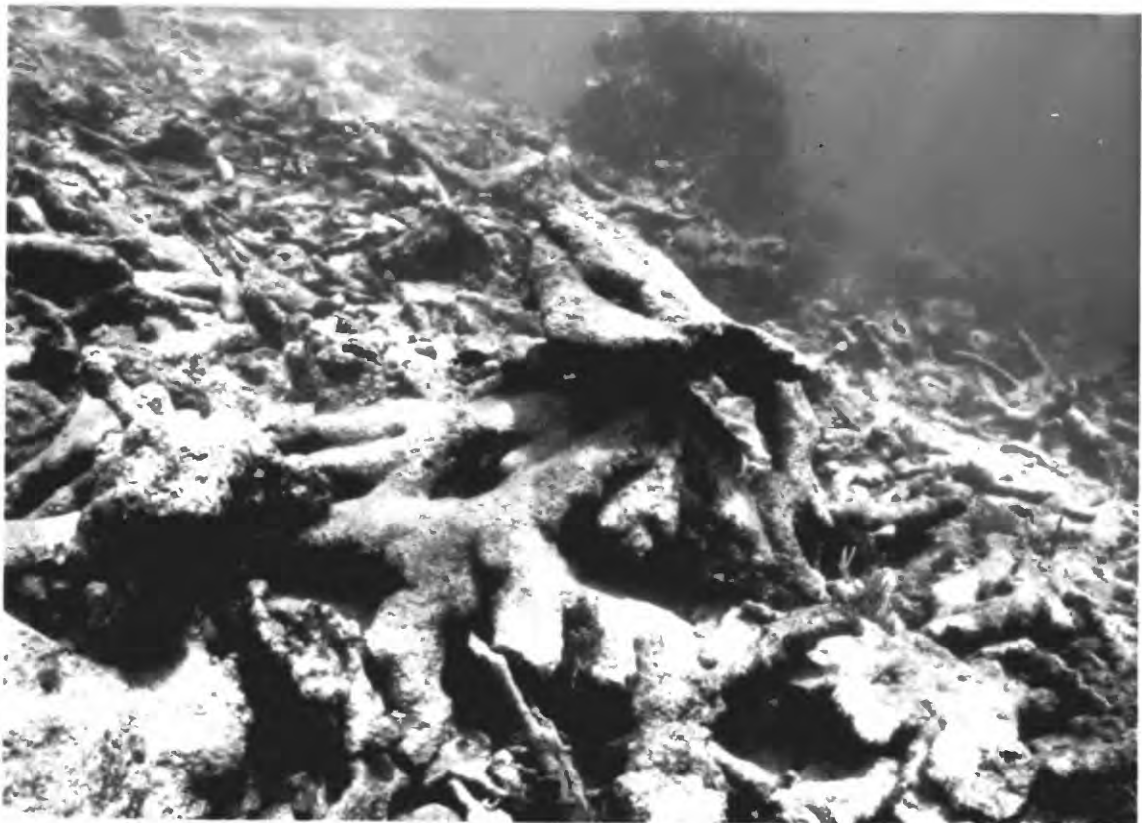
Fig. 2. Typical underwater views of damage to the principal reef building coral *Acropora palmata* on the east side of Culebra near station E (Fig. 1). All of these dead corals have been coated with encrusting algae.

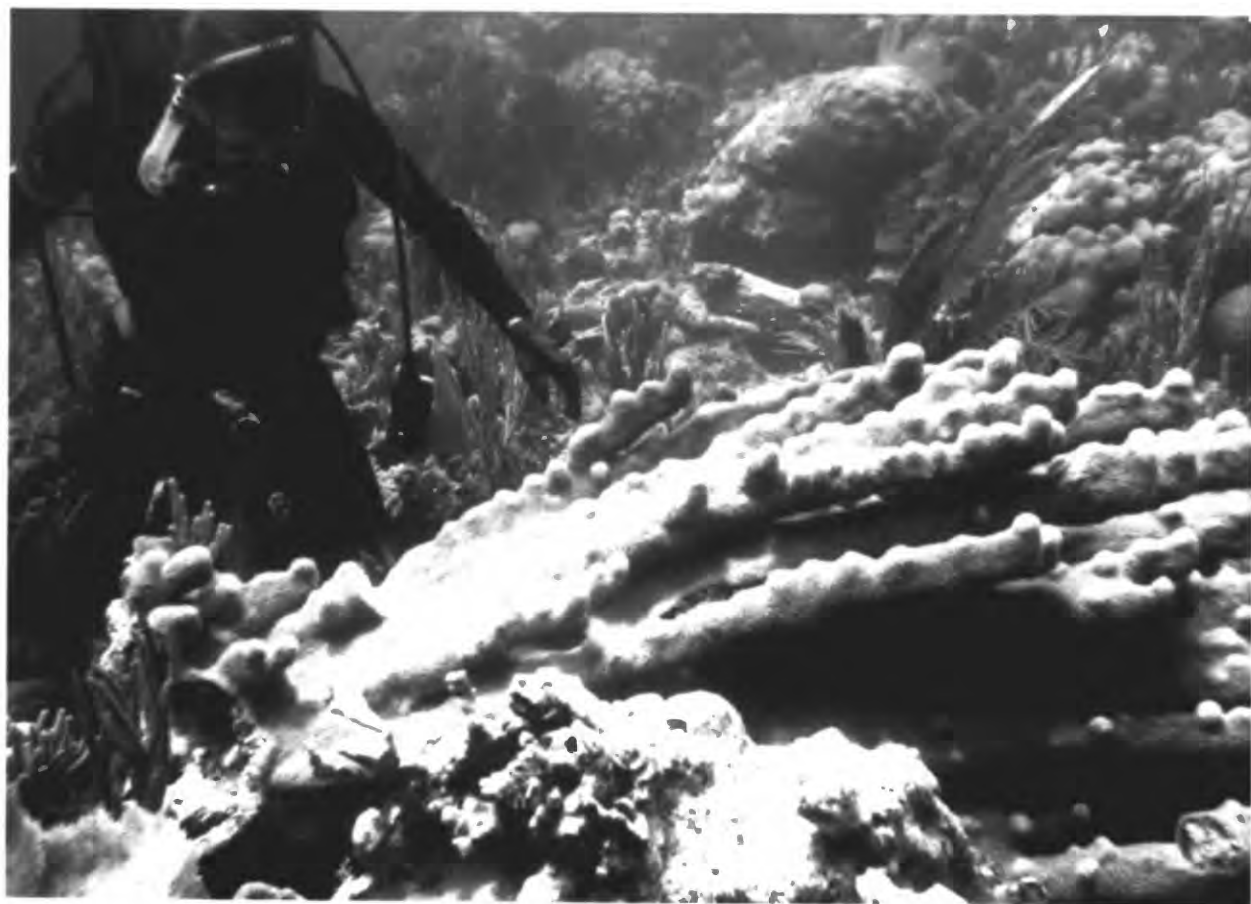
Fig. 3. Overturned Pillar coral, *Dendrogyra cylindrus* on the windward side of Culebra near station E (Fig. 1). This species is less common on the leeward side of the island near station C. Note upward directed knobs. Similar-sized growth knobs were observed on all overturned colonies. Amount of new growth is consistent with the known growth rate and period of time since Hugo struck.

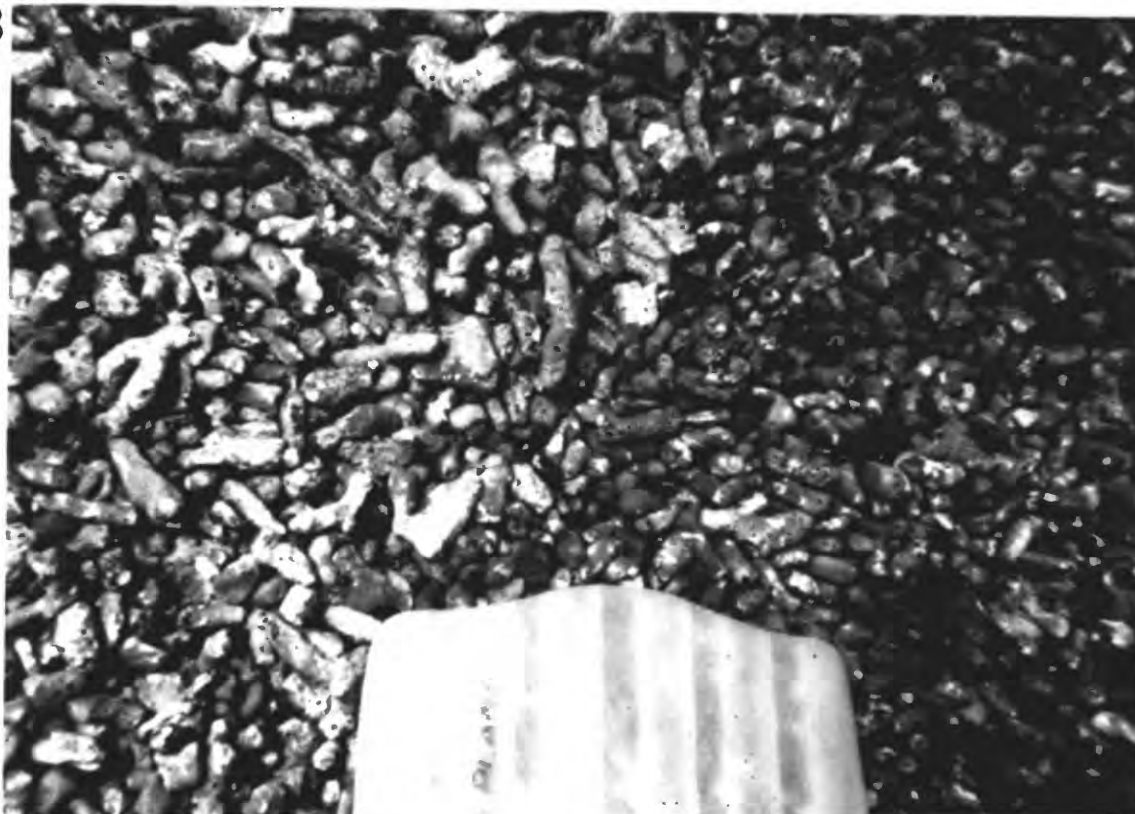
Fig. 4. (A) Healthy, unbroken colonies of *Porites porites* on the seaward (eastern side of Culebra. Here they form the underpinning of the *Acropora palmata*-capped, pinnacle reefs. Such reefs were absent on the western (leeward) side of Culebra (B) Gravel produced by breakage of *Porites porites* during Hurricane Hugo. Such scenes were present on numerous reefs east of Culebra and on the reefs along the south side of Esenada Honda.

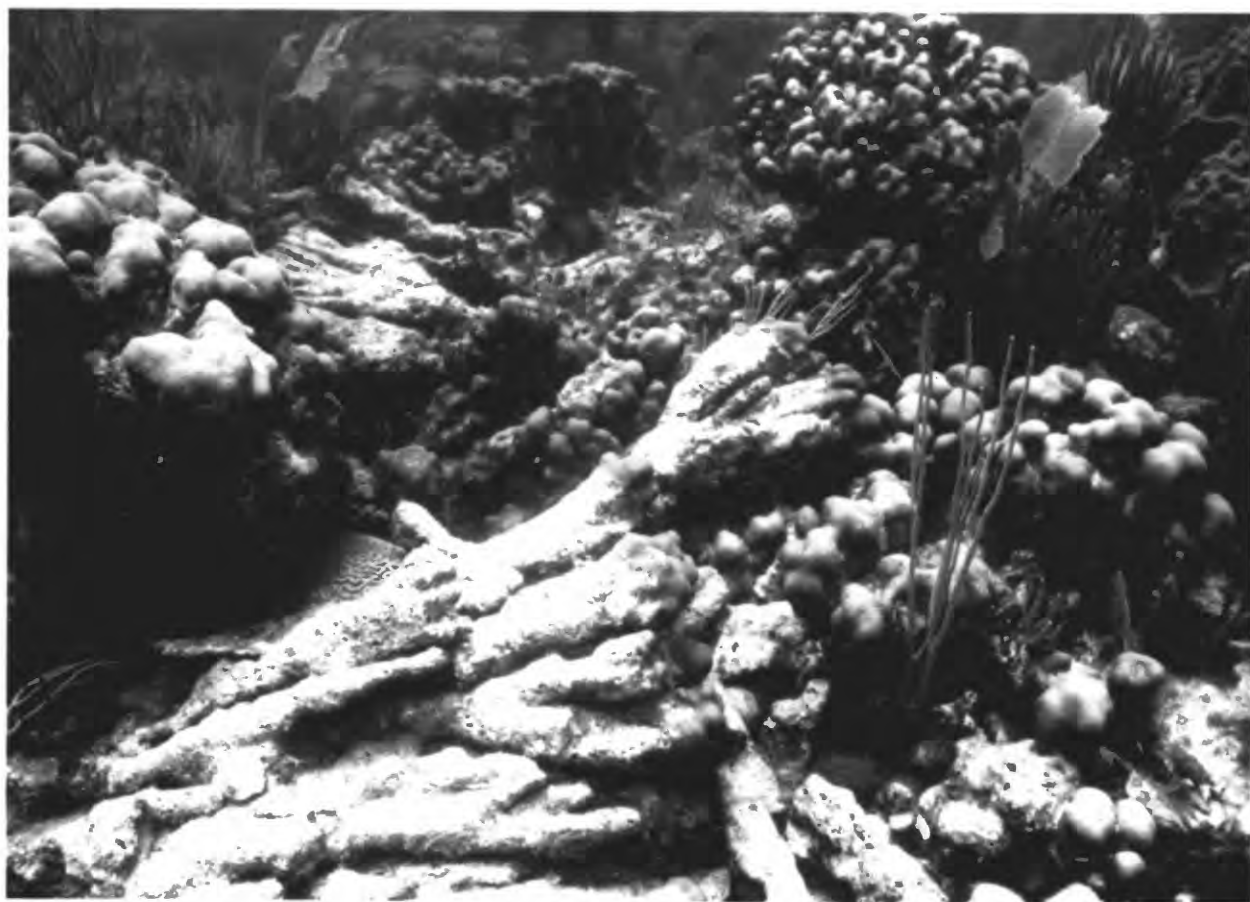
Fig. 6. Broken columns of the head coral *Montastrea annularis* from the west side of Culebra near station D (Fig. 1). Notice that tips of columns are living.
